# NINE-ELEMENT NONPOINT SOURCE IMPLEMENTATION STRATEGIC PLAN (NPS-IS) MILLERS FORK WATERSHED HUC-12 (050800020201)

PREPARED FOR THREE VALLEY CONSERVATION TRUST PREPARED BY ENVIRONMENTAL SOLUTIONS AQ

VERSION 1.0: NOVEMBER 9, 2023 APPROVED: NOVEMBER 9, 2023

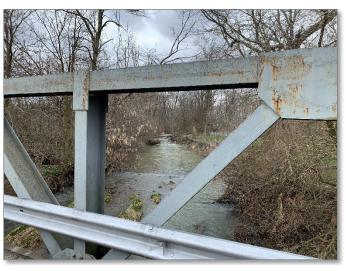
Millers Fork HUC-12 and Twin Creek were surveyed in 2005 and the results showed that Millers Fork had good and marginally good water guality and were able to partially support WWH in the headwaters and partially support EWH beginning at Clark Road near Ithaca (Figure 2-11). The biological indicators suggested that water quality improvement through BMPs in the upland and nutrient management are important and required to support highguality habitats in Millers Fork and its tributaries. In the Millers Fork HUC-12, channelization, subsurface drainage and failing septic systems are the main sources of impairment locally. Nutrients

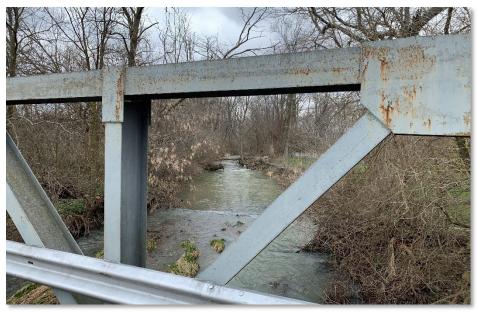
FIGURE 3-4 MILLERS FORK AT ITHACA

Ithaca, a village that has a total area of 19 acres and is located adjacent to Millers Fork, is not served by any wastewater treatment plant. Hence, all of the businesses,

churches, and homes in Ithaca -- as well as homes, typically on larger lots outside villages -rely on HSTS to treat sewage. The Clean Watershed Needs Survey conducted the Household Sewage Treatment System Failures in Ohio by the Ohio Department of Health in 2012 indicated the failure rate of HSTS in southwest Ohio was 18% (ODH, 2013). However, the Darke County General Health Department (DCGHD) stated the failure rate for the Village of Ithaca is estimated to be significantly higher. Many citizen complaints about raw sewage entering surface waters near Ithaca have been reported by DCGHD. Rural homes throughout the watershed are also served by HSTS.
